SUNSET LAKE DAM

DE 00046

PHASE 1 INSPECTION REPORT

NATIONAL DAM SAFETY PROGRAM

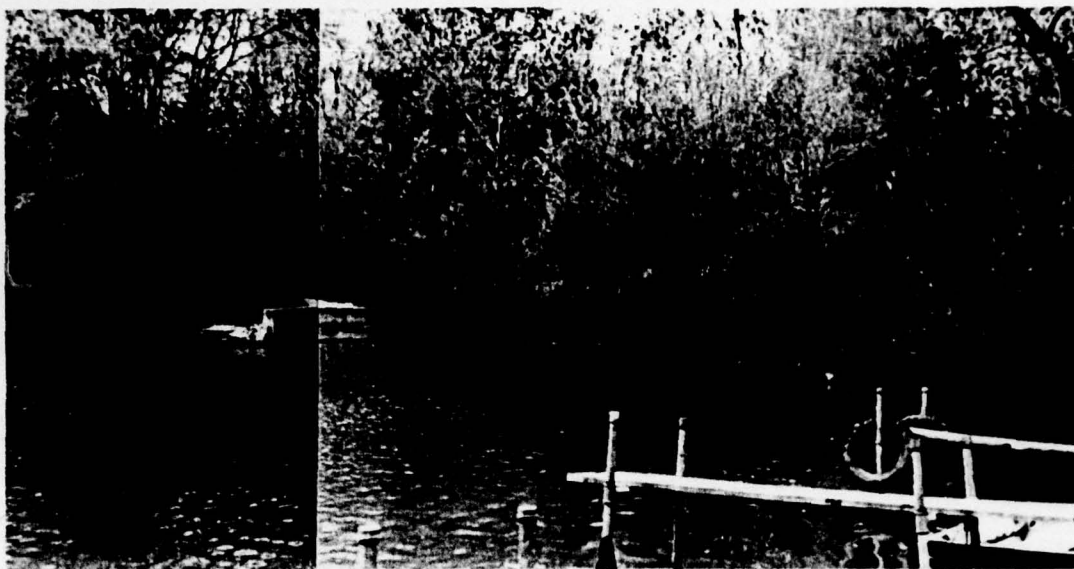
- PHOTO 1 - View of overflow structure and adjoining embankments.
- PHOTO 2 - View overlooking west wing wall of concrete overflow structure and intersecting west embankment. Debris on the crest of structure and erosion of the embankment are notable on the photograph.
